EXCAVATIONS AT KARATAŞ-SEMAYÜK AND ELMALI, 1974

MACHTELD J. MELLINK

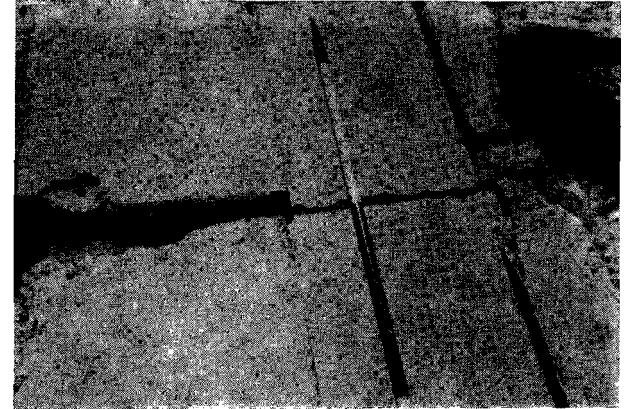
Fig. 6 - Detail of limestone base, remnants of clamps. Karaburun il.

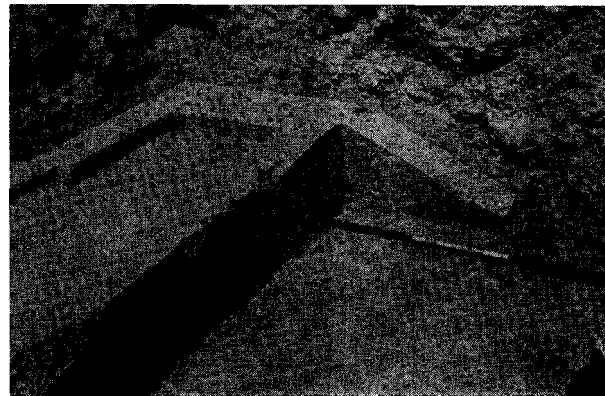
Fig. 7 - Detail of limestone base : parapet on North side.

had been observed here in a drainage channel near the edge of the tumulus. A trench cut to investigate the stones revealed the presence of a large limestone base, measuring 4.96 x 1.35 x 0.58 m. (figs. 1-7). Its long side is roughly parallel to the façade of the tomb chamber at a distance of c. 16 m. (fig. 1). The base is built of two blocks, originally held together by swallowtail clamps, now missing (fig. 6). It was set in the slope of the tumulus, its top at a level 1.50 m. below that of the floor of the tomb chamber. The outer stone coating of the tumulus was also packed around the sides and the rear of the base. The front of the base was freestanding and protected on each side by a triangular stone acting as a parapet (fig. 7).

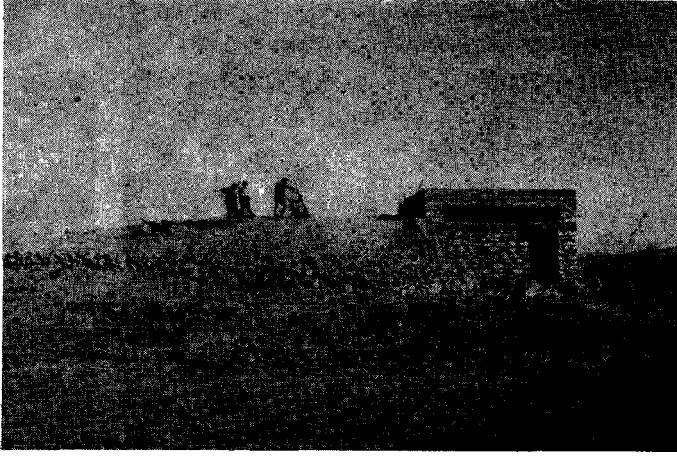
Fig. B- Kizilbel. *View of rebuilt Amulus and entrance building.

As designed, the structure consists of three parts. The tumulus has been rebuilt over the tomb chamber. A small entrance room (measuring 3.50 x 4.50 m.) stands on the South slope, half embedded in the tumulus (fig. 12). From here a staircase leads down to a subterranean anteroom (2.50 x 4.80 m. with a maximum interior height of 3.00 m.) which gives access to the tomb chamber (figs. 10-11). The entire façade of the tomb can be seen in this anteroom, the roof of which projects over the front part of the roof of the tomb chamber. The stone kline, stone table, and stone door of the tomb chamber will eventually be displayed in this anteroom, after restoration of the badly destroyed fragments. The tomb
