## EXCAVATION REPORT, ESKİ ANAMUR (ANEMURIUM), 1968

Prof. Leonard C. SMITH

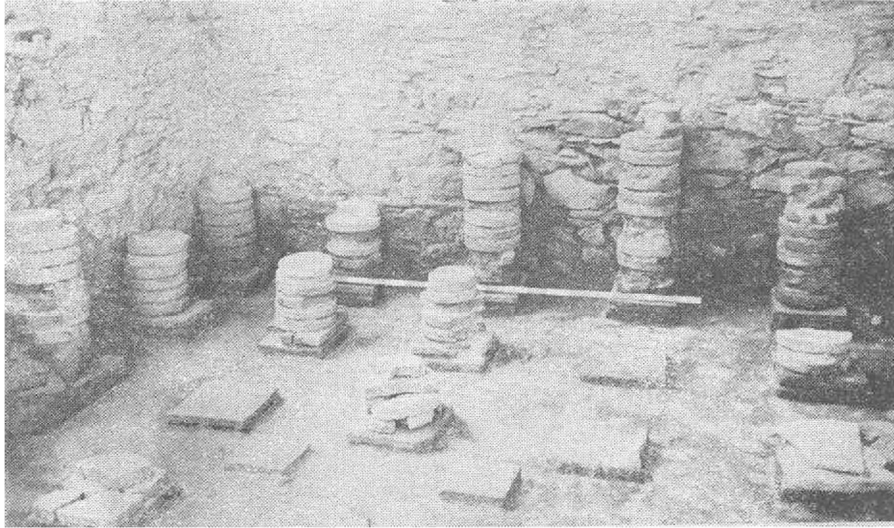
ANAMU 7+1 (1968 - Bldg. II 07 A, Hypocaust pillars in Room 2 . 'A?9?4 A

in this building, which was originally a large bath-house at the extreme S. end of the site near the theatre, rooms C and D (see plan) were excavated and freed of collapsed material which had been consolidated into a crude floor replacing the early hypocaust and associated pavement. Some 35 - 40 pillars of round clay plaques, averaging 1.20 m. in height were found *in situ*, while in addition twin pairs of circulating tunnels, averaging a little over 1 m. high, opened out under the adjoining rooms B and G. Special care had also been paid to the construction of a marble-lined footbath at the NE entrance to Room C, ensuring a continuous circulation of warm water.

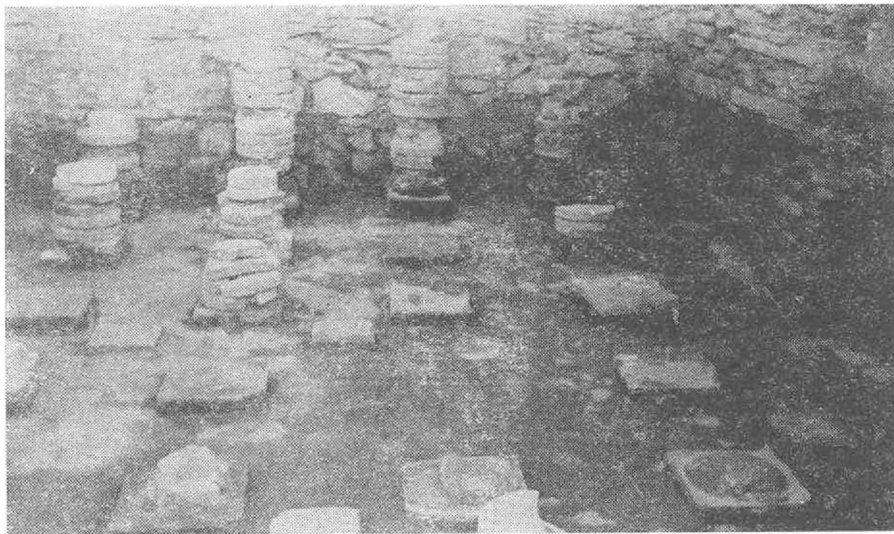
ANAMU 7+1 (1968 - Bldg. II 07 A, Hypocaust pillars and Substructure of foot bath A 9

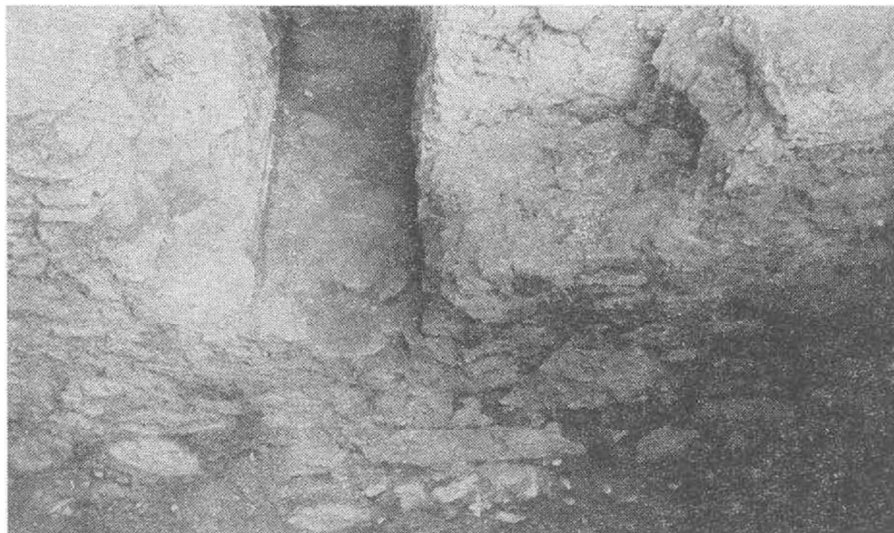
ANAMU 7+1 (1968 - Bldg. II 70 A, Flue channel into Room CD 2 I 4 95

To the south the area beyond the main wall between the projecting chambers R and K was excavated, revealing a furnace room 2.10 m. x 2.70 m. connected

by a horizontal flue running into the building under Room D. It was in this area that the chief finds of the season were made, consisting of a deposit of more than 700 unused clay handlamps in 7 main types of decoration, including crosses, human faces and stylized animal and foliage patterns. Comparison with specimens elsewhere would indicate a 6th/7th century A. D. date of manufacture. Perhaps still more significant for dating purposes, there appeared in the lowest levels of the excavation in the stoke-hole, 20 - 25 cm. below the threshold level of the flue amid burnt matter and clinker 10 fragments of fine *terra sigillata* ware, one piece figured with the representation of a goat (?); the earliest construction of the bath-house as a working entity would then appear to belong to the late Republican - early Imperial Roman period, an indication in harmony with other evidence of building activity on the site at this time in particular.
